HISTORIC RESOURCES INVENTORY

1. Common name: _____
2. Historic name: Riksheim House
3. Street or rural address: 546 Fifth Street
City Gilroy Zip 95020 County Santa Clara
4. Parcel number: 79901802
5. Present Owner: Russel Hodges Address: P.O. Box 183
City Tres Pinos Zip 95075 Ownership is: Public _____ Private X
6. Present Use: Residence Original use: Residence

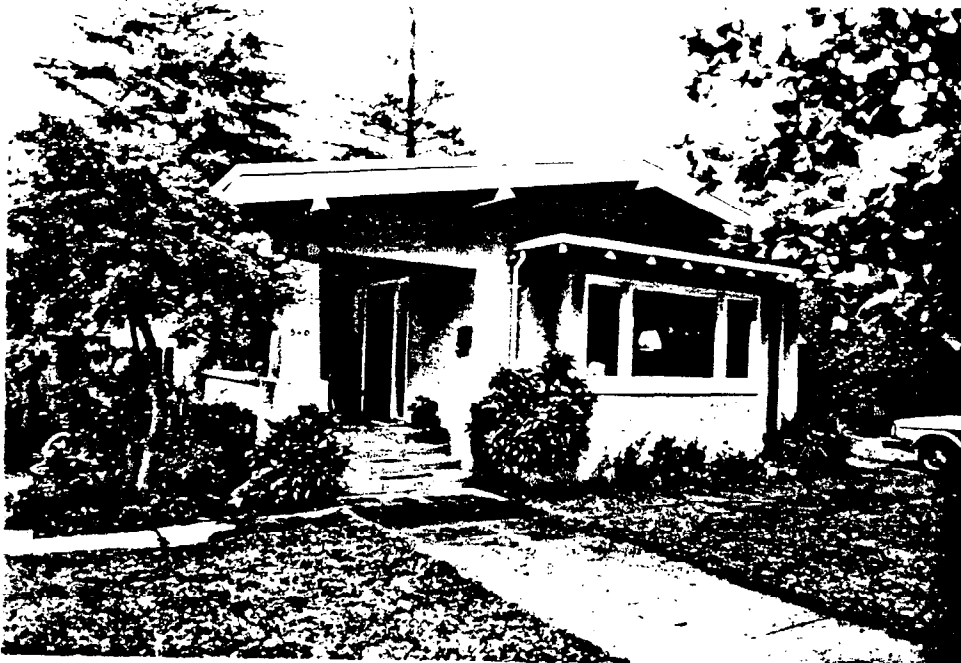
8672-31

This structure consists of a one story stucco building that was built in a rectangular plan. The roofline is covered with tar and paper. It is in very good condition. Distinctive features include the squared projecting bay with its horizontal-shaped tripartite window which dominates the street facade and the side entry porch with its single squared pillar as support. Four concrete straight steps lead to the porch. Characteristic craftsman elements include the very low gabled roofline with the characteristically exaggerated eave line punctuated by well spaced rafters. Note also the slight shed roof over the bay with its smaller rafters. Oversized and carved gable ends add some detail. Again landscaping unites this site with its neighbors.
