HISTORIC RESOURCES INVENTORY

1. Common name: \_\_\_\_\_
2. Historic name: Wilson House
3. Street or rural address: 237 Fifth Street  
 City Gilroy Zip 95020 County Santa Clara
4. Parcel number: 79900611
5. Present Owner: Joe Arellano Address: 237 Fifth Street  
 City Gilroy Zip 95020 Ownership is: Public \_\_\_\_\_ Private X
6. Present Use: Residence Original use: Residence

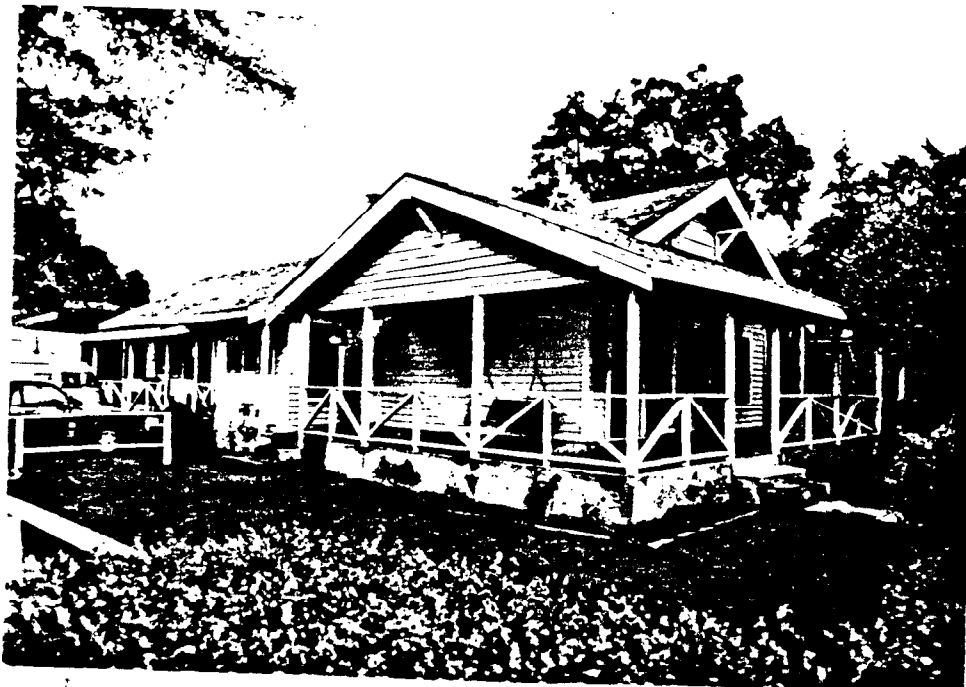
This large house has been divided into two separate houses and has an offset gable roofline with exposed rafters and support brackets. The siding is wide clapboard and the veranda porch extends around the west side of the house all the way to the rear. There are square posts on the porch and a railing of criss-crossed 1" x 4" wooden boards.

13. Condition: Excellent \_\_\_ Good X Fair \_\_\_ Deteriorated \_\_\_ No longer in existence \_\_\_
14. Alterations: Several alterations have transformed a Pioneer into a bungalow
15. Surroundings: (Check more than one if necessary) Open land \_\_\_ Scattered buildings \_\_\_ Densely built-up X  
Residential X Industrial \_\_\_ Commercial \_\_\_ Other: \_\_\_\_\_
16. Threats to site: None known X Private development \_\_\_ Zoning \_\_\_ Vandalism \_\_\_  
Public Works project \_\_\_ Other: \_\_\_\_\_
17. Is the structure: On its original site? X Moved? \_\_\_ Unknown? \_\_\_
18. Related features: Barn
