HISTORIC RESOURCES INVENTORY

1. Common name: _____
2. Historic name: _____
3. Street or rural address: 7180 Church Street
 City Gilroy Zip 95020 County Santa Clara
4. Parcel number: 79901030
5. Present Owner: Steve Baham Address: 1562 San Joaquin A
 City Gilroy Zip 95020 Ownership is: Public _____ Private X
6. Present Use: Residence Original use: Residence

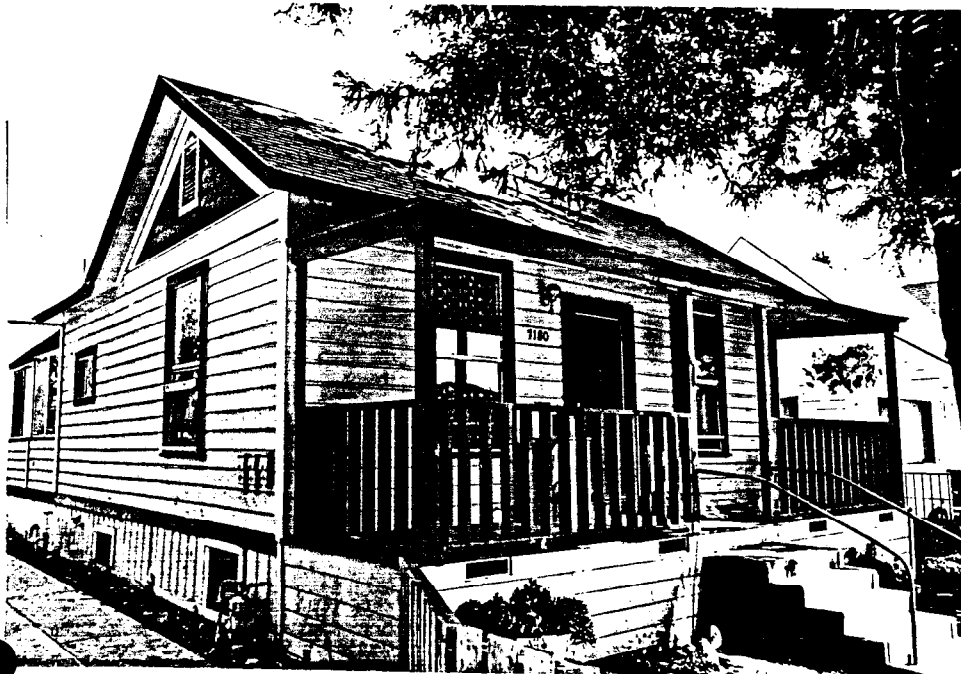
A one story structure of rectangular form. It is also referred to as a "hall and parlor" style, because of its very functional design containing three rooms. Additions, such as a shed to the rear or side, were necessary to accomodate modern kitchens and bathrooms. The entrance is in the center between two rectangular windows of double hung wood sash. The frame of both door and windows is simple Greek revival. The structure is sheathed in horizontal board with grooved and fitted joints.

13. Condition: Excellent ___ Good X Fair ___ Deteriorated ___ No longer in existence ___
14. Alterations: Rear extension, concrete stairs
15. Surroundings: (Check more than one if necessary) Open land ___ Scattered buildings ___ Densely built-up X
Residential X Industrial ___ Commercial ___ Other: ___
16. Threats to site: None known X Private development ___ Zoning ___ Vandalism ___
Public Works project ___ Other: ___
17. Is the structure: On its original site? X Moved? ___ Unknown? ___
18. Related features: Mature trees

The site's significance is due to its architectural style and the fact that it is in such good repair. This pioneer has Queen Anne touches in the fish scale shingle decoration under the gable. The concrete steps and pipe railing are unfortunate additions.
