HISTORIC RESOURCES INVENTORY

1. Common name: _____
2. Historic name: _____
3. Street or rural address: 7257 Egleberry Street
 City Gilroy Zip 95020 County Santa Clara
4. Parcel number: 79900931
5. Present Owner: Frances Bozzo Address: 780 Eschenberg Dri
 City Gilroy Zip 95020 Ownership is: Public _____ Private X
6. Present Use: Residence Original use: Residence

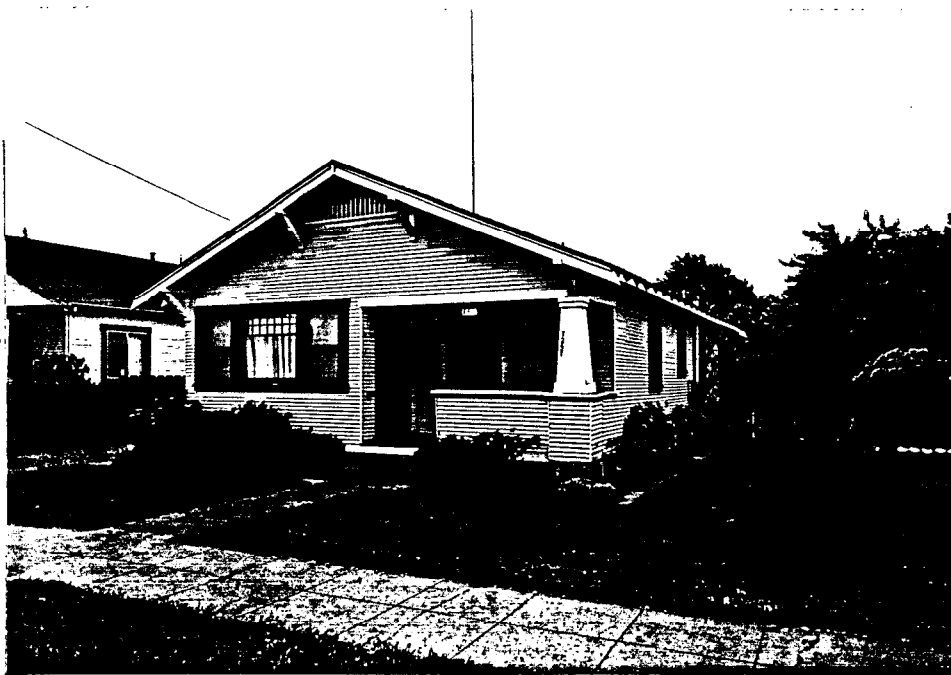
A single story rectangular structure with a low pitch end gable facade, the exposed eave and brackets together with narrow horizontal board siding are elements of the craftsman style. In this case, a modest style replicated by local contractors in several locations.

13. Condition: Excellent ___ Good X Fair ___ Deteriorated ___ No longer in existence ___
14. Alterations: _____
15. Surroundings: (Check more than one if necessary) Open land ___ Scattered buildings ___ Densely built-up X
Residential X Industrial ___ Commercial ___ Other: _____
16. Threats to site: None known X Private development ___ Zoning ___ Vandalism ___
Public Works project ___ Other: _____
17. Is the structure: On its original site? X Moved? ___ Unknown? ___
18. Related features: _____
