# HISTORIC RESOURCES INVENTORY

1. Common name: \_\_\_\_\_
2. Historic name: \_\_\_\_\_
3. Street or rural address: 7272 Church Street  
 City Gilroy Zip 95020 County Santa Clara
4. Parcel number: 79900948
5. Present Owner: Norbert Alanis Address: 7272 Church Street  
 City Gilroy Zip 95020 Ownership is: Public \_\_\_\_\_ Private X
6. Present Use: Residence Original use: Residence

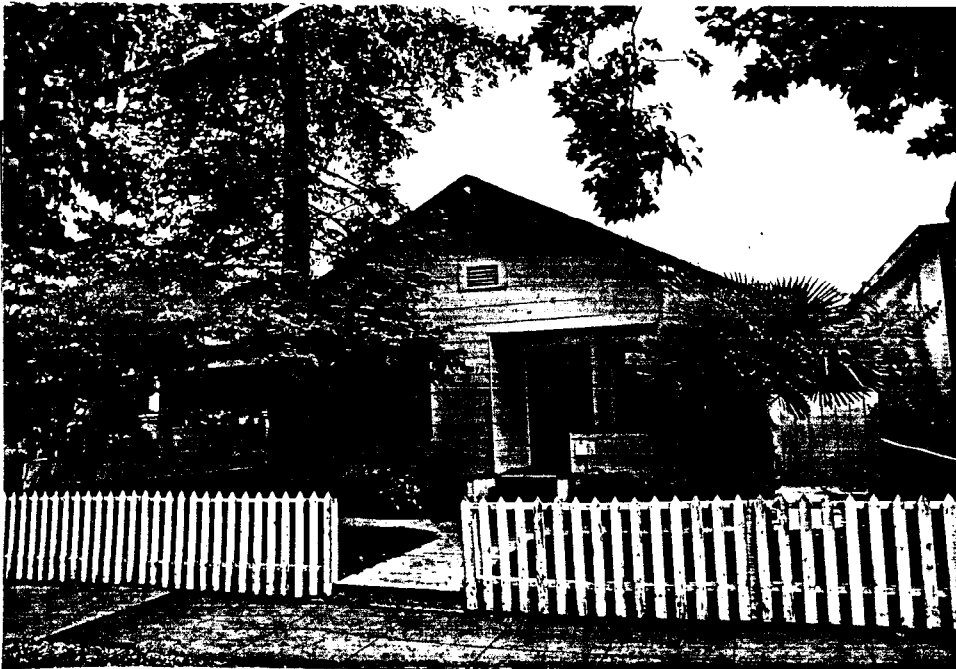
This small bungalow has a medium gable roof with exposed rafters and support brackets. It has horizontal board siding with windows facing the street and a wood slat vent centered in the gable. The side porch is recessed with a low walk in matching siding.
