HISTORIC RESOURCES INVENTORY

IDENTIFICATION Sportsman's Club

3. Street or rural address: 7360 Monterey street
 City Gilroy Zip 95002 County Santa Clara

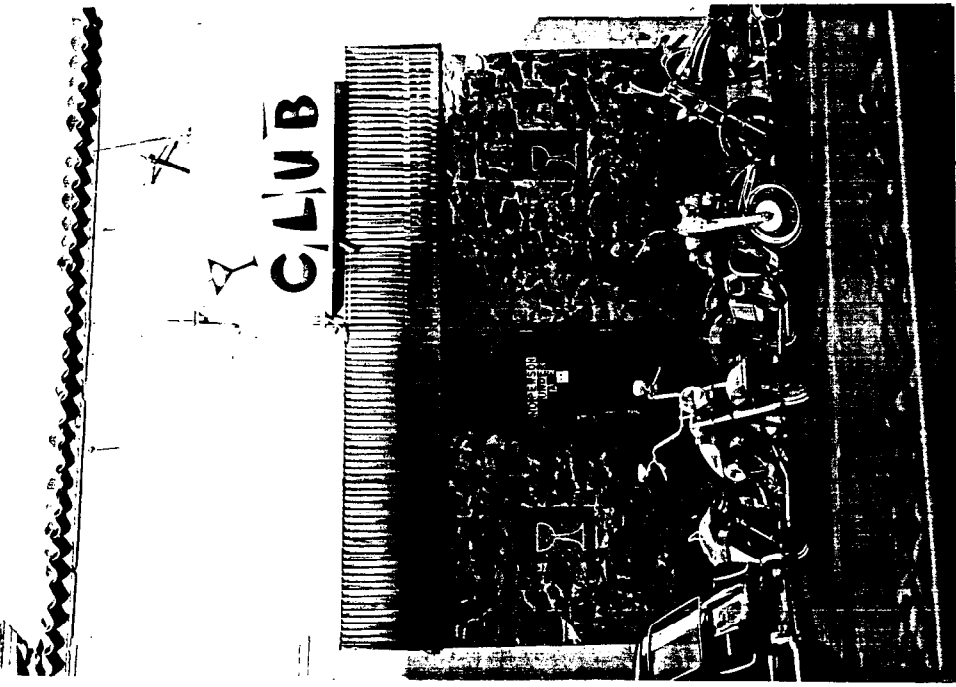
The structure consists of a long, low, single-story reinforced concrete building constructed on a rectangular plan and designed in a very minimalist Spanish colonial revival/commercial style. As with its neighbor at 7390 Monterey Street, the building helps provide a Spanish colonial revival touch to central Gilroy. The building, again like its neighbor, was also constructed originally as an automotive store. It is defined by large square apertures (consisting of plate glass windows and doors) which are separated by squared pillars. The area above the store front entries is unadorned plaster with small incised ornamental garlands. A line of red tiles defines the false front roof.
