HISTORIC RESOURCES INVENTORY

- 1. Common name: _____
- 2. Historic name: _____
- 3. Street or rural address: 7391 Egleberry Street
City Gilroy Zip 95020 County Santa Clara
- 4. Parcel number: 79900813
- 5. Present Owner: Theo Welden Address: 300 S. Second Street
City San Jose Zip 95113 Ownership is: Public _____ Private X
- 6. Present Use: Apartments Original use: Residence

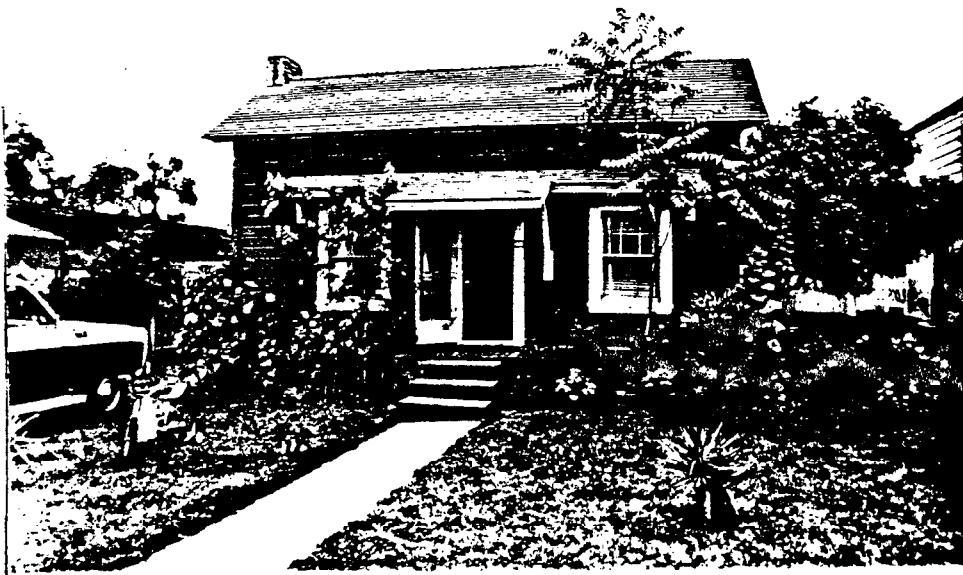
There is no porch on this structure, only a stoop without railings or ornamentation. A shed roof is supported by craftsman style brackets. This probably dates a move for this structure.

A classic Gilroy pioneer house, important for its minimal alterations. The modifications in architectural elements, brackets to support the overhang and brick work in the chimney indicate this was moved to the present site in the early craftsman era. This little pioneer is not as nice as the house on the former location of the livery, stable on Second Street. It is on the same lot as the stable, however.
