HISTORIC RESOURCES INVENTORY

1. Common name: _____
2. Historic name: _____
3. Street or rural address: 7419 Monterey Street
 City Gilroy Zip 95020 County Santa Clara
4. Parcel number: 79900764
5. Present Owner: George Hall Address: P.O. Box A
 City Gilroy Zip 95020 Ownership is: Public _____ Private X
6. Present Use: Store Original use: commercial

- 7a. Architectural style: False Stepped Front Commercial
- 7b. Briefly describe the present *physical appearance* of the site or structure and describe any major alterations from its original condition:

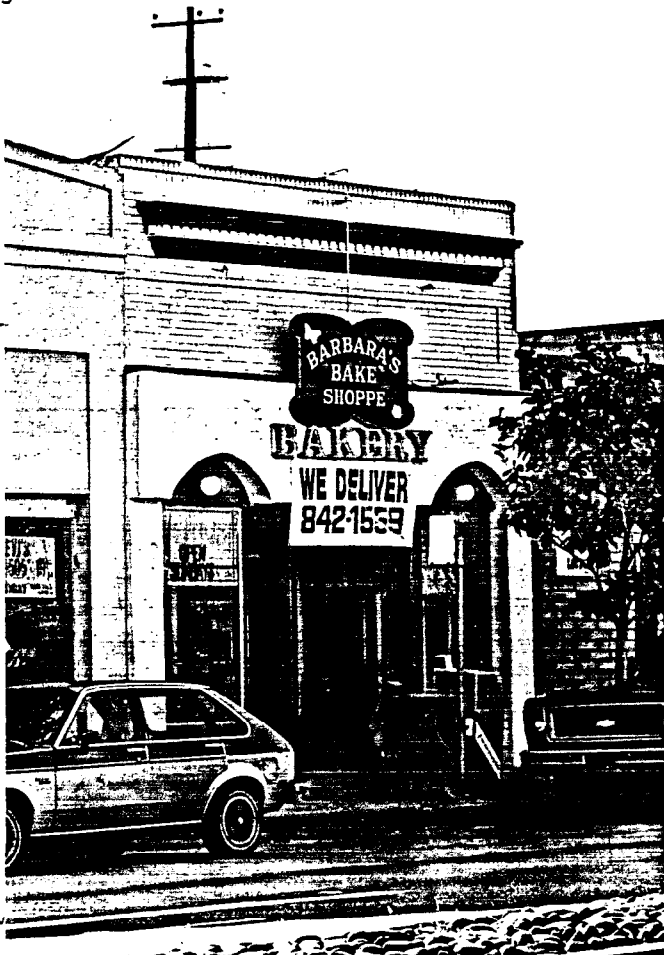
This one story rectangular structure has a facade that has been remodeled at the storefront. The upper area has a plain recessed pannel with a projecting cornice of molded metal. The brick structure is exident in the upper facade. A row of soldier birck finalizes the top of this flat roofed structure. Even with the storefront alterations, this building is a significant element in the early 1900 downtown architecture of Gilroy.

13. Condition: Excellent ___ Good ^ Fair ___ Deteriorated ___ No longer in existence ___
14. Alterations: Facade brock is painted and a pseudo arch decoration has been added.
15. Surroundings: (Check more than one if necessary) Open land ___ Scattered buildings ___ Densely built-up X
Residential ___ Industrial ___ Commercial X Other: _____
16. Threats to site: None known X Private development ___ Zoning ___ Vandalism ___
Public Works project ___ Other: _____
17. Is the structure: On its original site? X Moved? ___ Unknown? ___
18. Related features: _____
