HISTORIC RESOURCES INVENTORY

Mr. Art's

1. Common name: \_\_\_\_\_
2. Historic name: Phone Exchange and Barber Shop
3. Street or rural address: 7525 Monterey Street  
City Gilroy Zip 95020 County Santa Clara
4. Parcel number: 79900650
5. Present Owner: Vernon Naughton Address: 575 Fifth Street  
City Gilroy Zip 95020 Ownership is: Public \_\_\_\_\_ Private X
6. Present Use: Shoe Store Original use: Commercial

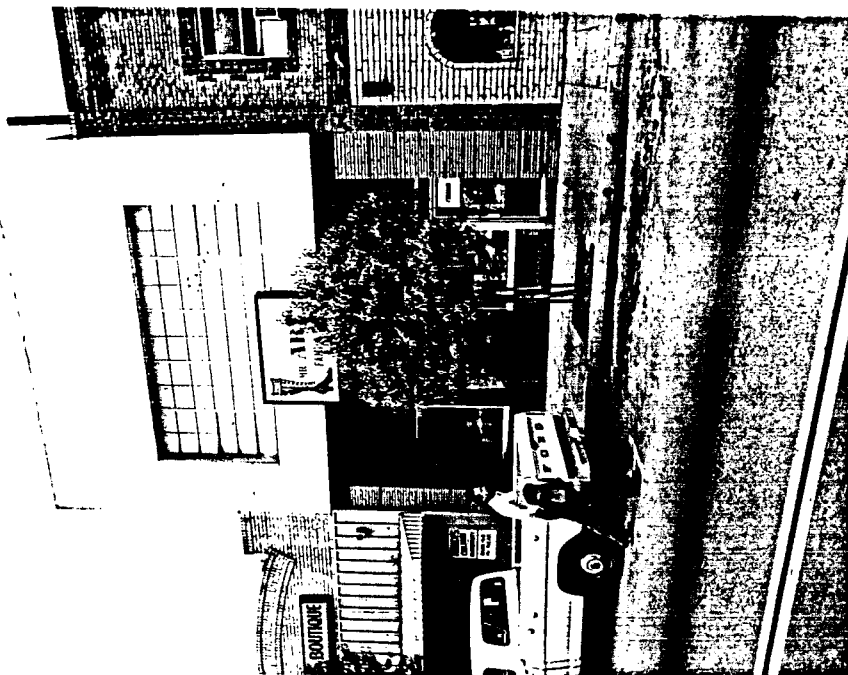
The site is a small, two story brick commercial building which has been altered on the street facade. Plaster covers the brick and a large indented rectangular space provides the major ornament. The first floor commercial space is a deep recessed entry with angled glass display cases surrounding a centered front door. A two story concrete addition is found on the rear of the building and a single story cinder block addition further has been added to the back of the site. Note that the bland remodeling of the structure comprises the building's quality as an individual site, but the size massing and first floor commercial space all keeps the basic design elements that define the urban form of Gilroy's central business district.

13. Condition: Excellent \_\_\_ Good X Fair \_\_\_ Deteriorated \_\_\_ No longer in existence \_\_\_
14. Alterations: Storefront and stucco covering
15. Surroundings: (Check more than one if necessary) Open land \_\_\_ Scattered buildings \_\_\_ Densely built-up X  
Residential \_\_\_ Industrial \_\_\_ Commercial X Other: \_\_\_\_\_
16. Threats to site: None known X Private development \_\_\_ Zoning \_\_\_ Vandalism \_\_\_  
Public Works project \_\_\_ Other: \_\_\_\_\_
17. Is the structure: On its original site? X Moved? \_\_\_ Unknown? \_\_\_
18. Related features: \_\_\_\_\_
