HISTORIC RESOURCES INVENTORY

1. Common name: _____
2. Historic name: _____
3. Street or rural address: 7790 Egleberry Street
City Gilroy Zip 95020 County Santa Clara
4. Parcel number: 79900365
5. Present Owner: Jack Kazanjian Address: 831 Third Street
City Gilroy Zip 95020 Ownership is: Public _____ Private X
6. Present Use: Commercial Original use: Residence

California Bungalow

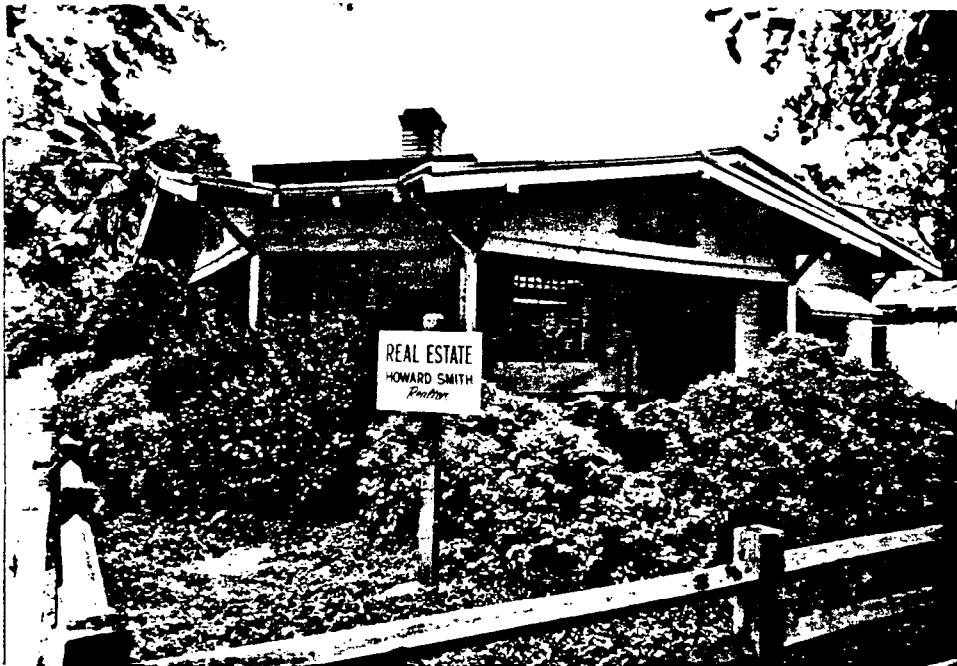
This stucco house has a double low gable roofline noted for its wideness, exposed rafters and support brackets and the veranda porch which characterize it as a typical California bungalow. The porch is supported by square wooden columns and extends around the corner from the front of the house facing Egleberry street to the Second street side. There are many alterations, including the brick wall at the corner and the cement landing.

13. Condition: Excellent Good _____ Fair _____ Deteriorated _____ No longer in existence _____
14. Alterations: Brick wall and cemet landing
15. Surroundings: (Check more than one if necessary) Open land _____ Scattered buildings _____ Densely built-up
Residential Industrial _____ Commercial _____ Other: _____
16. Threats to site: None known Private development _____ Zoning _____ Vandalism _____
Public Works project _____ Other: _____
17. Is the structure: On its original site? Moved? _____ Unknown? _____
18. Related features: _____
