HISTORIC RESOURCES INVENTORY

1. Common name: _____
2. Historic name: _____
3. Street or rural address: 7797 Egleberry Street
 City Gilroy Zip 95020 County Santa Clara
4. Parcel number: 79900325
5. Present Owner: Carl Grube Address: 7797 Egleberry St
 City Gilroy Zip 95020 Ownership is: Public _____ Private X
6. Present Use: Residence Original use: Residence

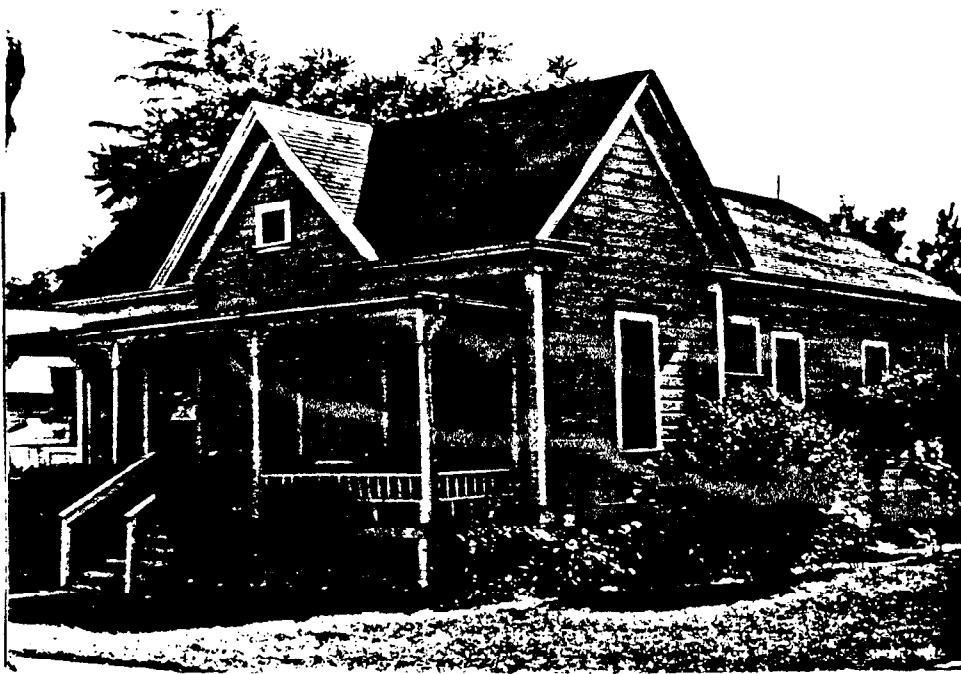
This pioneer cottage located on a corner lot has a cross cut gable roofline with enclosed eaves, a plain frieze and Greek influence returned corners at the bottom ends of the gables. It has wide clapboard siding and a raised foundation which gives the house a later, more classic look. The veranda porch has beveled columns which are decorated with band sawn scrollwork brackets where the columns meet the porch roof. There is a rectangular "eyebrow" window located above front door, a square window vent in the gable and wooden stick railing around the porch.

13. Condition: Excellent Good _____ Fair _____ Deteriorated _____ No longer in existence _____
14. Alterations: minor
15. Surroundings: (Check more than one if necessary) Open land _____ Scattered buildings _____ Densely built-up
 Residential Industrial _____ Commercial _____ Other: _____
16. Threats to site: None known Private development _____ Zoning _____ Vandalism _____
 Public Works project _____ Other: _____
17. Is the structure: On its original site? Moved? _____ Unknown? _____
18. Related features: _____
