HISTORIC RESOURCES INVENTORY

1. Common name: \_\_\_\_\_
2. Historic name: \_\_\_\_\_
3. Street or rural address: 7832 Eigleberry Street  
City Gilroy Zip 95020 County Santa Clara
4. Parcel number: 79900102
5. Present Owner: Ann Logan Address: 7832 Eigleberry S  
City Gilroy Zip 95020 Ownership is: Public \_\_\_\_\_ Private X
6. Present Use: Residence Original use: Residence

- 7a. Architectural style: Classic Box
- 7b. Briefly describe the present *physical appearance* of the site or structure and describe any major alterations from its original condition:

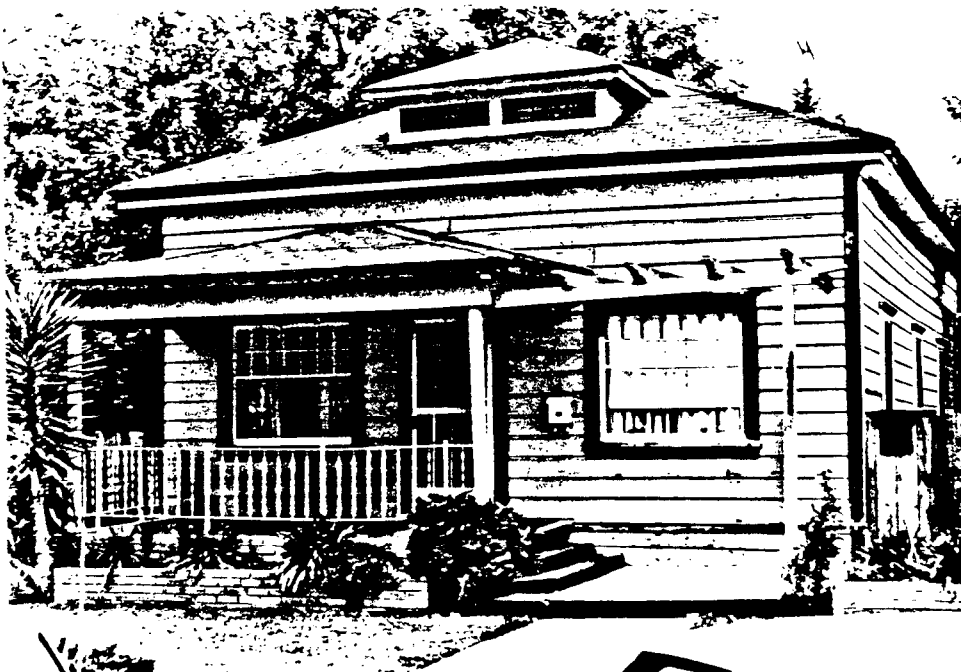
The classic characteristics of this rare style of house include the hipped roof and the enclosed eaves. There is a lattice windowed dormer on the roof facing the street, wide clapboard siding and a veranda porch supported by thin square columns.

This classic box is an architectural style not popular in Gilroy. Therefore, this is an important and rare example of this style. The very classic window crowns on the sides give a clue that the front has been modified. Not a significant work, this residence fits well with the other older structures in this area.
