HISTORIC RESOURCES INVENTORY

1. Common name: \_\_\_\_\_
2. Historic name: \_\_\_\_\_
3. Street or rural address: 7841 Hanna Street  
City Gilroy Zip 95020 County Santa Clara
4. Parcel number: 79902006
5. Present Owner: Jerrold Mills Address: 7841 Hanna Street  
City Gilroy Zip 95020 Ownership is: Public \_\_\_\_\_ Private X
6. Present Use: Residence Original use: Residence

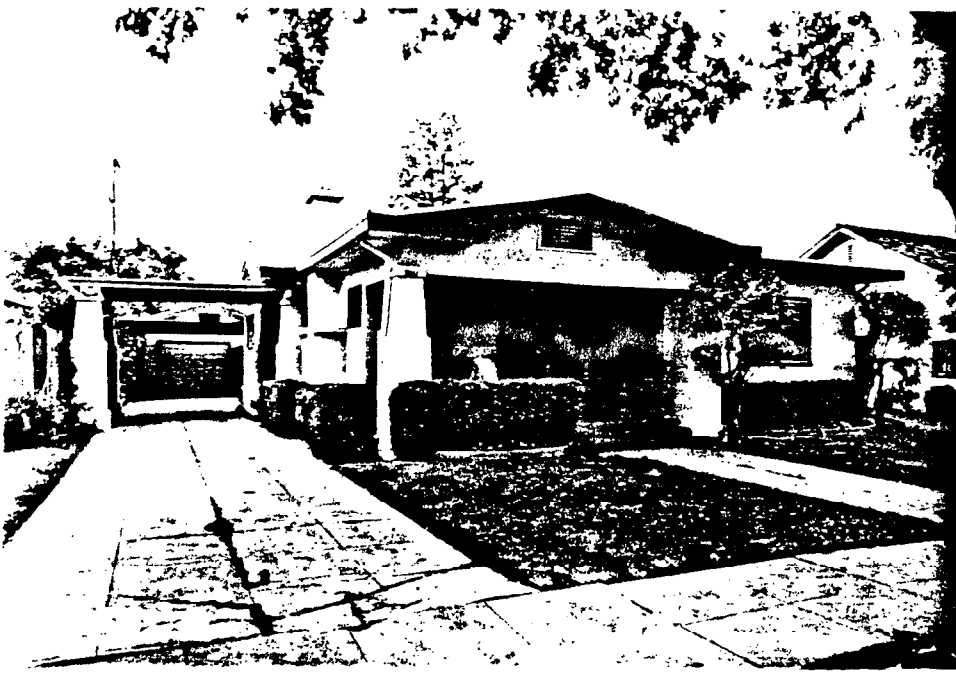
This basic California bungalow has some unusual features that are not very craftsman: A roofline so slightly gabled that it's almost flat and a front gable that turns in at the corners in classic Greek style. Also very uncharacteristic on this stucco house are the enclosed eaves while the elephantine columns on the recessed porch and the covered trellis over the driveway fit in as standard decor on this street.

13. Condition: Excellent  Good \_\_\_\_\_ Fair \_\_\_\_\_ Deteriorated \_\_\_\_\_ No longer in existence \_\_\_\_\_
14. Alterations: \_\_\_\_\_
15. Surroundings: (Check more than one if necessary) Open land \_\_\_\_\_ Scattered buildings \_\_\_\_\_ Densely built-up   
Residential  Industrial \_\_\_\_\_ Commercial \_\_\_\_\_ Other: \_\_\_\_\_
16. Threats to site: None known  Private development \_\_\_\_\_ Zoning \_\_\_\_\_ Vandalism \_\_\_\_\_  
Public Works project \_\_\_\_\_ Other: \_\_\_\_\_
17. Is the structure: On its original site?  Moved? \_\_\_\_\_ Unknown? \_\_\_\_\_
18. Related features: \_\_\_\_\_
